Health assessment of traction-motor blowers regarding their deformation degradation

ABSTRACT

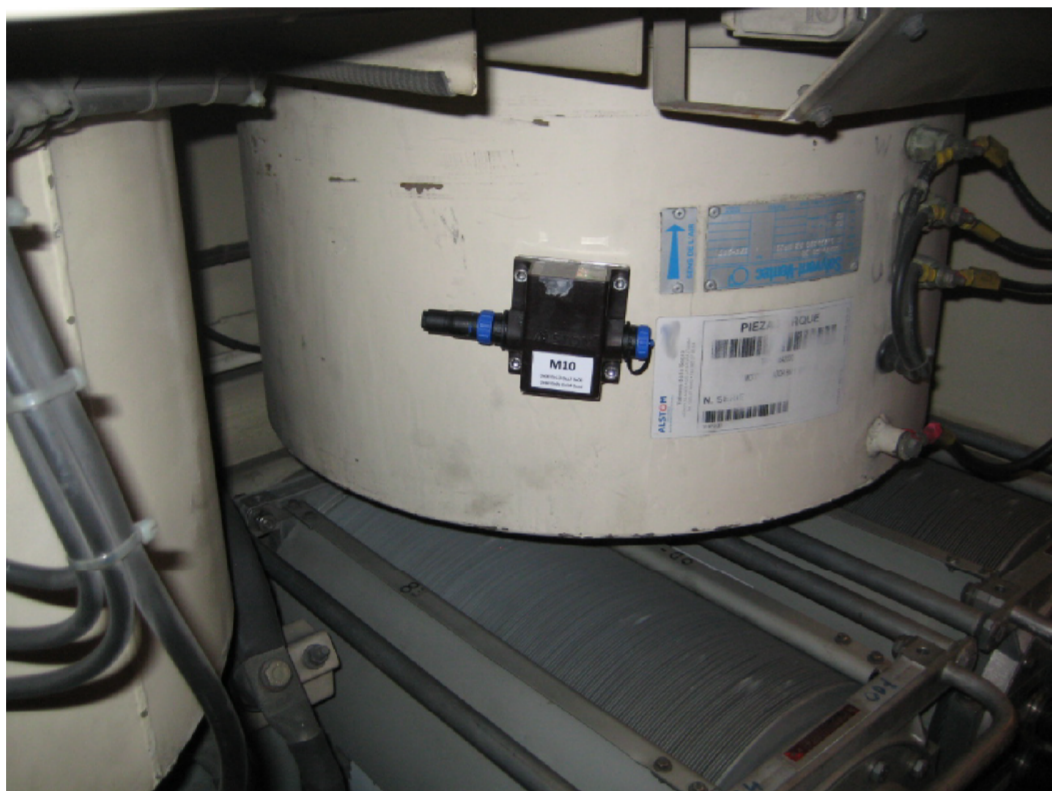
Figure 2. TheMotes installed on the outer casing of the traction-motor blower.

lowed in order to approach the predictive maintenance in an ordered manner, first extracting the signal features, and then deploying models to conduct the diagnostics and the prognostics. We will particularly focus our efforts on the detection and management of the turbine deformation, because this is not being properly addressed by the current maintenance approach. In order to do so, the vibration of the blowers in operation will be acquired with a network of intelligent wireless sensors called TheMotes (A. Trilla and P. Gratacòs, 2013), see Figure 2. Vibration is a very rich proxy variable that encodes lots of information and denotes the presence and condition state of rotating mechanical components. TheMotes were chosen because they are non-intrusive (magnetically attached to the outer casing), do not require cabling (data is forwarded wirelessly from device to device and finally collected with a tablet), do not interfere with the operation of the system and are ideal for retrofitting. They acquire a vibration signal with 3 axes, during 10 seconds, and with a sampling rate of 3.2kHz using an on-board Micro-Electro Mechanical System-based sensor.

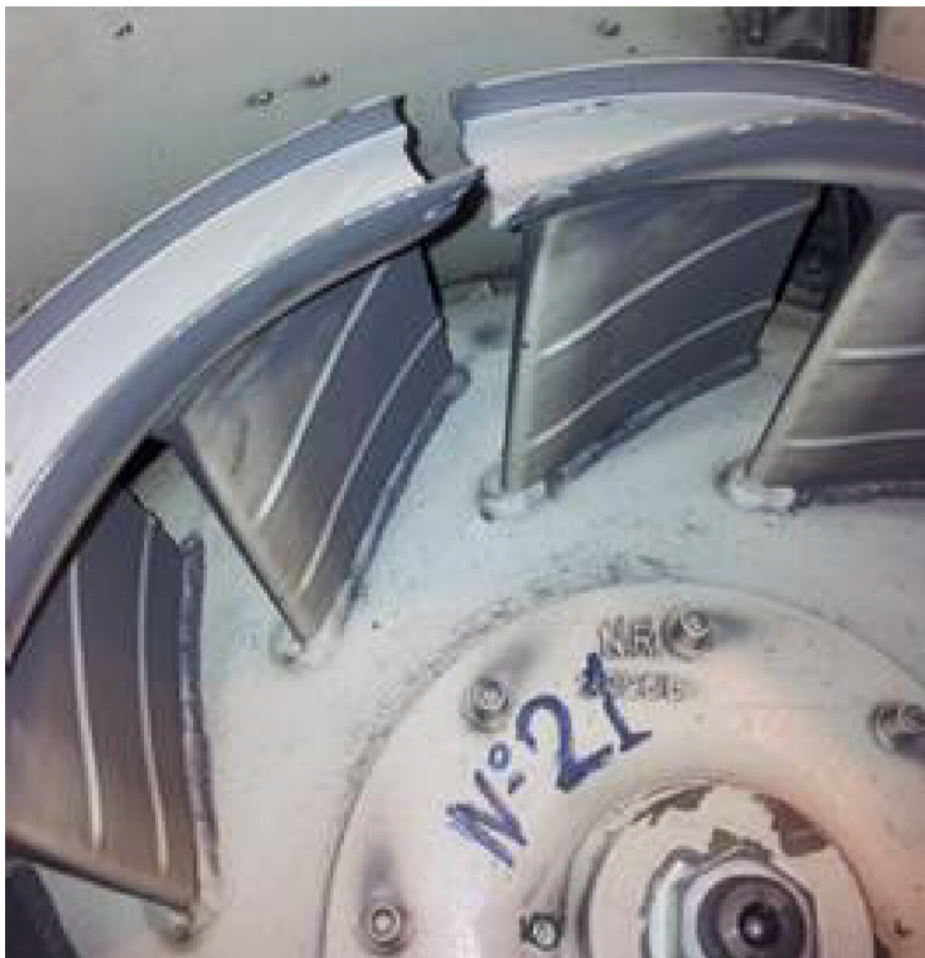
Figure 5. Service-affecting failure of a traction-motor blower. Note how the turbine has been heavily deformed before breaking.

Note that many of the indicator values for these failing traction-motor blowers have been masked by the overall behaviour of the fleet, i.e., they don't show significantly anomalous values, except for blower 01-01-01. It is possible that the service-affecting failure develops so fast that its signature could not be acquired during the monitoring of the sample. Figure 5 shows an example of such catastrophic failures.
